Client: 17674A Vista Del Lago

**Comp #:** 102 Concrete - Repair/Replace

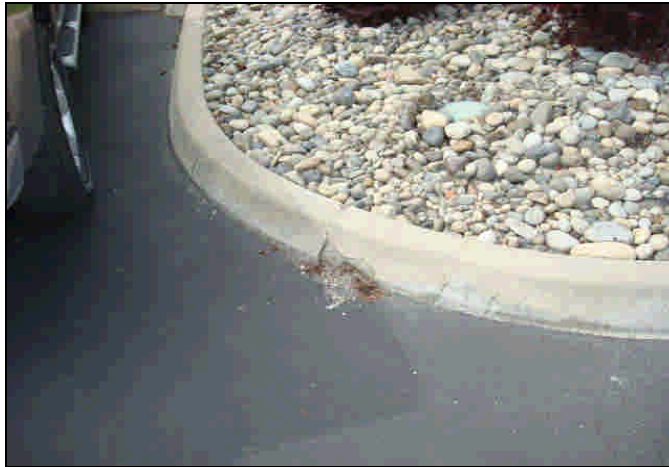
Evaluation: Three curb types: rolled (majority), extruded (pictured) and reinforced. Sidewalk around clubhouse. Most in generally good condition; some local cracking and spalling noted. There is no predictable expectation for total replacement, but expect some repair needs to mount as association ages. It is typically difficult to get vendor to perform small repairs at reasonable cost, and therefore we suggest setting aside a repair allowance for these areas every few years to supplement the operating budget. Time larger repairs when practical to coincide with Asphalt - Seal/Repair (Component #202) for cost efficiency. Paint any required curbs and fire lanes at that time as well. As routine maintenance, inspect regularly, pressure wash for appearance and fill local cracks as needed using general maintenance & repair funds. Note: see component 1200 for pool deck.

Best Case: \$1,000.00  
Lower allowance for repair

Worst Case: \$2,000.00  
Higher allowance for repair; more extensive

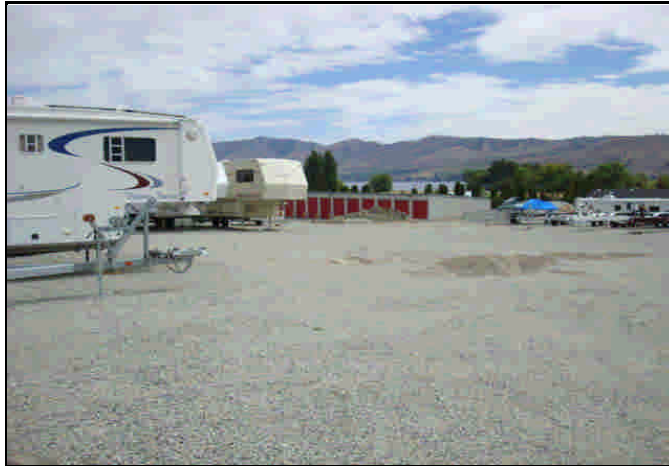
Comp #: 106 RV Lot - Refurbish

Evaluation: Generally functional area - gravel fairly well distributed and compacted at the time of our inspection. Treat periodic replenishment and regrade as general maintenance expense in year of occurrence (large maintenance funding in current operating budget). Association reportedly needs to install a retaining wall in this area in 2009. Preliminary estimates are in the \$12,000 to \$20,000 range, projected as one-time project below. No plans in place to pave within the foreseeable future - incorporate funding into reserve study updates if pavement is elected. Again, treat gravel work as maintenance expense.

Lower allowance for one time retaining wall installation

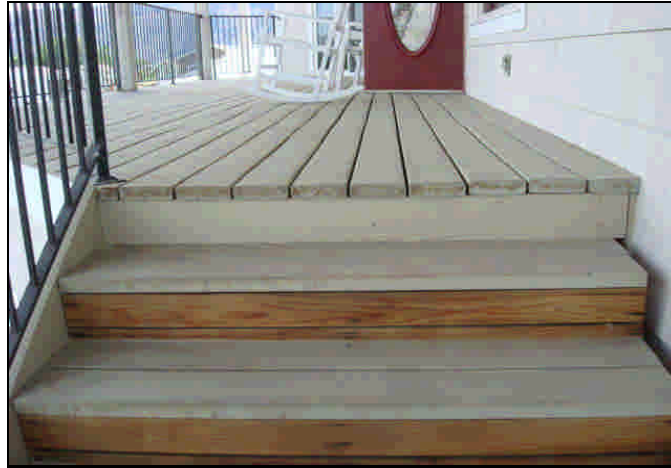
**Comp #:** 116 Decks, Stairs - Repair/Replace

Evaluation: Generally fair to good, stable condition at the time of our inspection. No areas of rot or other advanced wear noted. Composite decking with pressure treated structural members. Plan for roughly 20 years of service life before large scale repair/replacement. Some periodic local repair work will likely be needed in future years - particularly at areas without roof to protect. Treat those local repairs as general maintenance expenses. Ensure that rail assembly is secure. Reserves suggested below for large scale repair/replacement.

Best Case: \$24,600.00  
\$30/Sq Ft, Lower allowance for repair/replacement

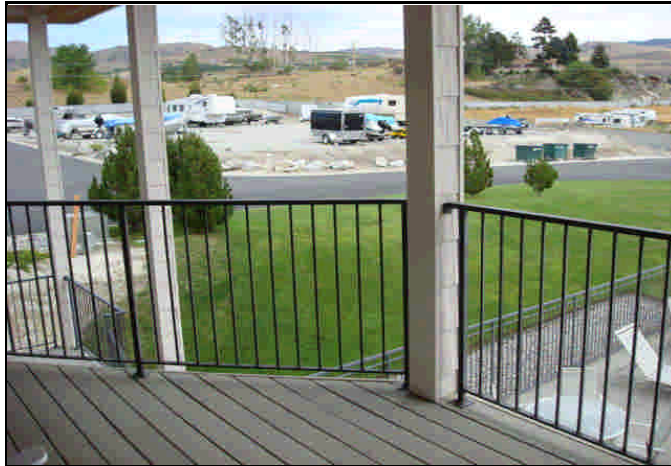
**Comp #:** 120 Deck, Stair Railing -Repair/Replace

**Evaluation:** Generally stable condition; some general fading and wear, small rust spots, but not significant at this time. See component #1107 for cyclical painting. This railing is a durable material with expected life of 30 to 40 years or more depending upon care and maintenance. We do not suggest setting aside reserves at this time. As routine maintenance, inspect regularly to ensure safety and stability; repair promptly as needed using general operating/maintenance funds. Note: pool rail / fence is addressed separately herein, component #1201. See component 1107 for painting information.

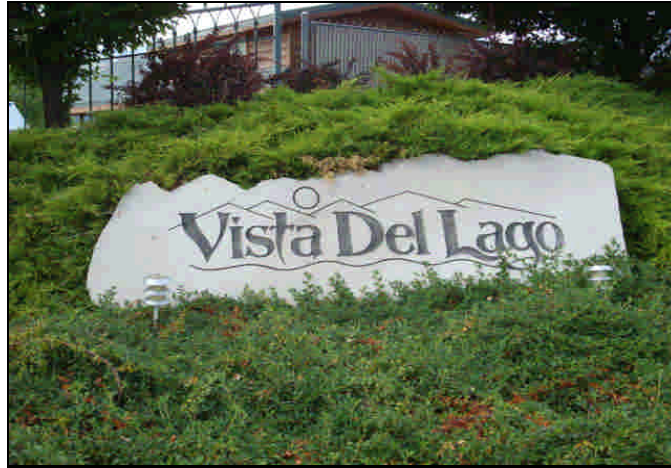
**Comp #:** 130 Signs - Replace

Evaluation: Good, legible condition of signs. Entry are stone monuments which should last indefinitely with ordinary care. There are a few small required signs at common areas (I.e., speed limit) that when replacement is needed should be less than \$200 and therefore best expensed as general maintenance items. As routine maintenance, inspect regularly, clean / touch up for appearance and repair from operating budget. No reserve funding suggested for signage.

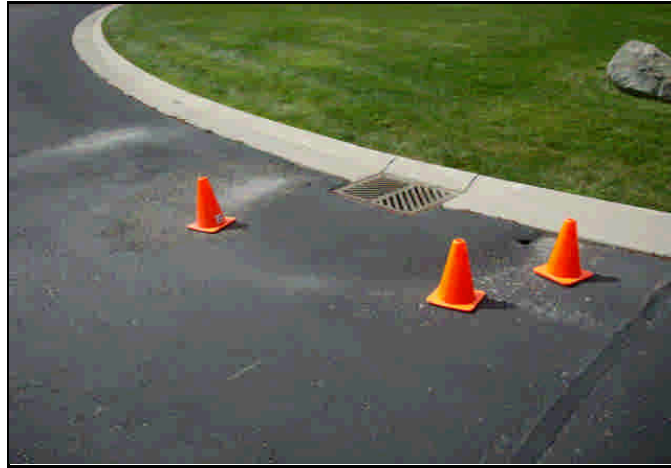
**Comp #:** 201 Asphalt - Resurface (Overlay)

Evaluation: Generally fair to good, intact condition. No widespread cracking, waviness, etc... One area where asphalt is undermined and a safety hazard (see photo). We suggest the association factor general annual repairs and cleaning (\$1,000 to \$2,000) within operating budget and cyclical seal coating and repair and eventual resurface within reserve schedule. Regular cycles of seal and repair (see component #202) are recommended for maximum design life. As routine maintenance, keep surface clean and free of debris, ensure that drains are free flowing, repair cracks and clean oil stains promptly. Assuming proactive maintenance, plan to resurface (grind, overlay) at roughly the time frame below.

Best Case: \$145,530.00  
\$1.80/Sq Ft, lower estimate to resurface (overlay)

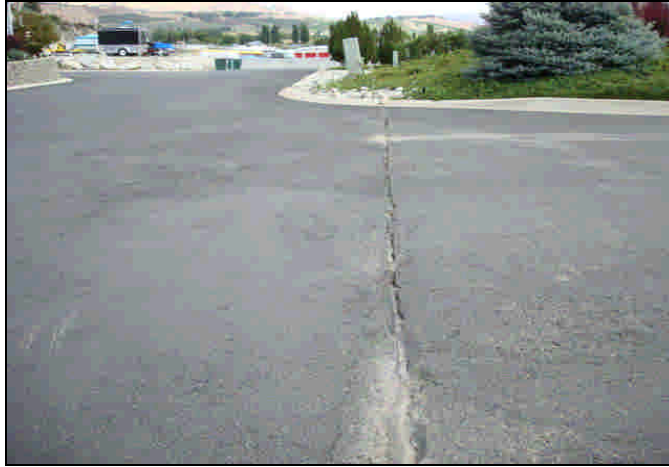
**Comp #:** 202 Asphalt - Seal/Repair

Evaluation: Generally fair surface condition; some fading and wear since last reported seal coat in 2007. Large crack noted (see photo). Regular cycles of seal coating (along with any needed repair) has proven to be the best program in our opinion for the long term care of lower traffic asphalt areas such as these. Seal coating protects against damaging weather elements while bridging small surface cracks and providing uniform appearance over the inevitable patching and repairs needed over time, ultimately extending total life. Apply two coats or flood application of quality asphalt emulsion, XLR-8 or similar. Surface preparation is key to lasting performance. Incorporate any striping and curb repair into this project. Fill cracks and clean oil stains promptly in between cycles as routine maintenance.

\$.18/Sq Ft, lower estimate to clean/seal/stripe

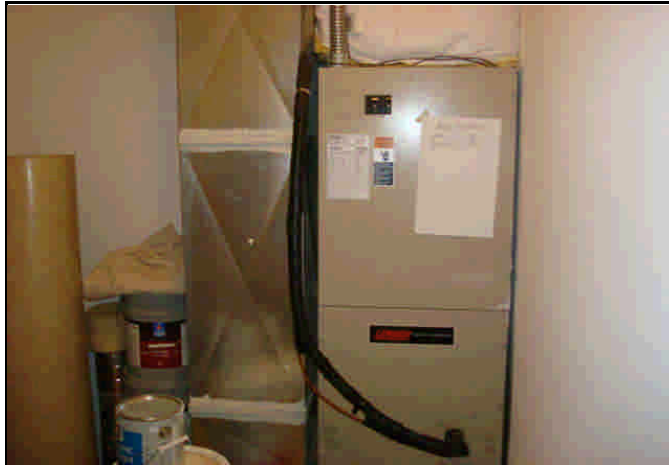
**Comp #:** 303 HVAC Units - Replace

Evaluation: Assumed to be in functional condition- no reported problems. As routine maintenance, regular professional inspections and maintenance will help to extend useful life cycles. Plan for replacement at the typical service life expectancy indicated below.

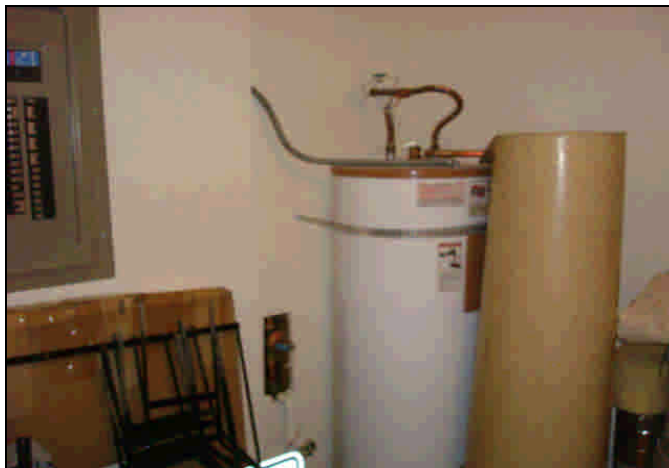
**Comp #:** 305 Water Heater - Replace (a)

Evaluation: Generally fair condition; no leaks or apparent corrosion noted. Regular inspections and maintenance is recommended. Best to plan for replacement at the typical life expectancy of fifteen years.

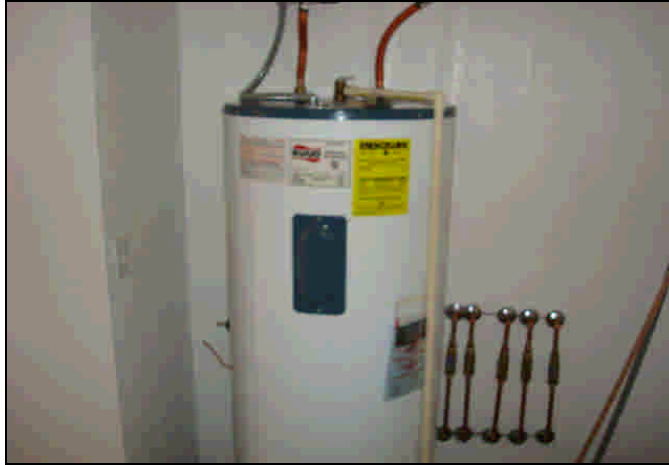
**Comp #:** 305 Water Heater - Replace (b)

Evaluation: Generally fair condition; no leaks or apparent corrosion noted. Regular inspections and maintenance is recommended. Best to plan for replacement at the typical life expectancy of fifteen years.

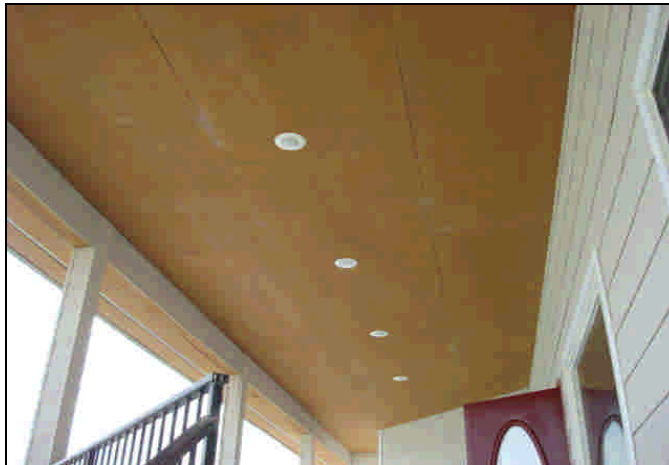
**Comp #:** 324 Exterior Lights - Replace

Evaluation: Observed during daylight hours and assumed to be in functional operating condition. As routine maintenance, inspect, repair/change bulbs as needed. No predictable expectation to replace all at once or in large scale, so best to treat as general maintenance issue. If association wishes to add exterior lighting at some point which is more subject to weather elements, funding can be incorporated into reserve study updates. No reserve funding suggested at this time.

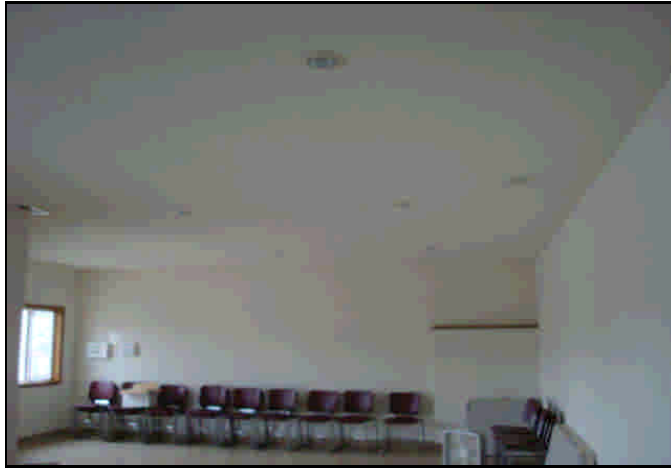
**Comp #:** 325 Interior Lights - Replace

Evaluation: Generally functional condition. As routine maintenance, inspect, repair/change bulbs as needed. With ordinary care and maintenance, there is no predictable expectation to replace all at once or in large scale at these protected interior locations. Evaluate needs each year and replace individual fixtures locally as needed using general maintenance and repair funds.

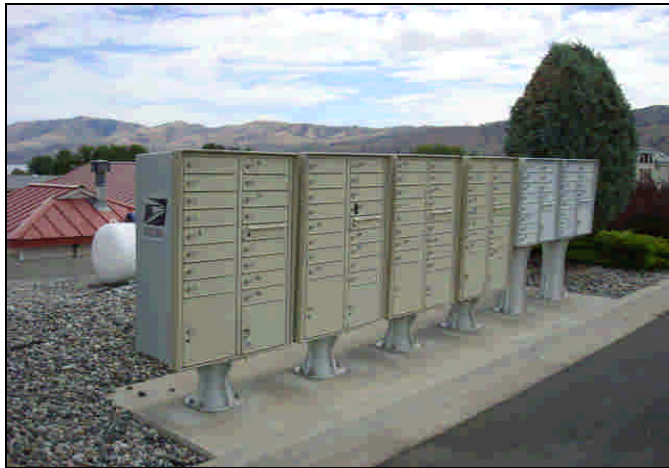
**Comp #:** 403 Mailboxes - Replace

Evaluation: Generally fair, stable condition. Some fading and wear, but no conditions that appear to affect function. As routine maintenance, inspect regularly, clean by wiping down for appearance, change lock cylinders, lubricate hinges and repair as needed from operating budget. Best to plan for total replacement at roughly the time frame below due to constant usage and wear over time. Note: USPS has a limited budget for replacement and should not be relied upon for purposes of long term planning.

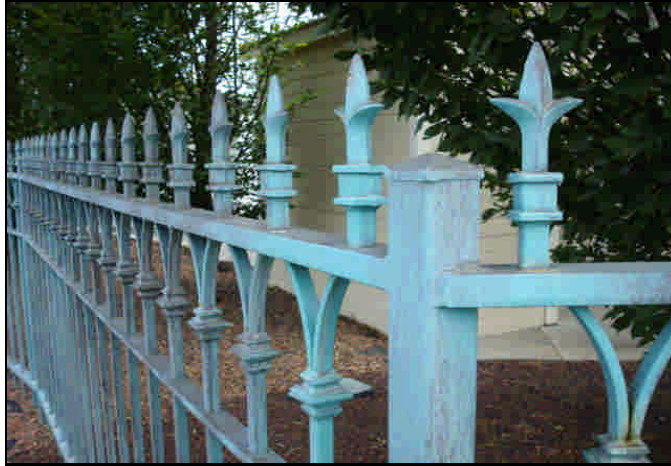
**Comp #:** 503 Metal Fence/Rail - Replace

Evaluation: These sections of ornate railing are in good condition with no damage or instability noted. Higher quality than type at pool perimeter and deck of clubhouse. With ordinary care and maintenance (periodic inspection and local repair) there is no predictable expectation to replace in large scale as reserve project. Treat as general maintenance issue.

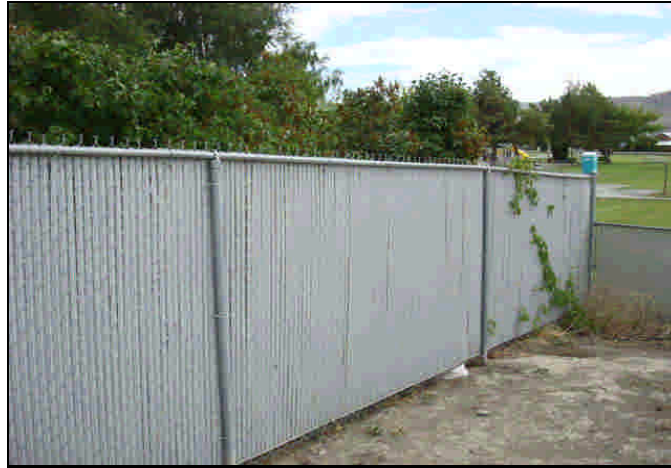
**Comp #:** 505 Chain Link Fence - Total Replace

Evaluation: Generally fair to good, stable condition. Local sections replaced not long ago after wind storm (vendor indicates thinner posts and slats caused to fall down). Research with Chaparal fence suggests planning to replace the vinyl slats every ten years or so and the complete fence every 20 to 25 years. In our experience, a thirty year schedule is more appropriate. As routine maintenance, inspect regularly for any damage, repair as needed using general maintenance funds. Plan to remove and replace at roughly the time frame below.

\$23/LF, lower estimate to remove and replace

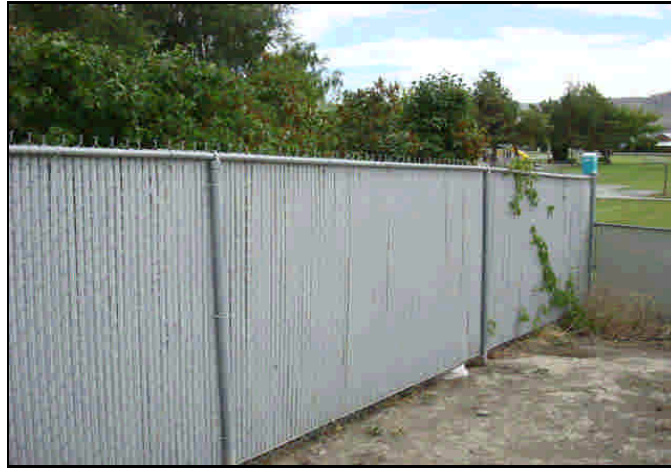
**Comp #:** 505 Chain Link Vinyl Slats - Replace

Evaluation: Generally fair condition. Local sections replaced not long ago after wind storm. Research with Chaparal fence suggests planning to replace the vinyl slats every ten years or so and the complete fence every 20 to 25 years. We have scheduled replacement of the slats below at 15 year intervals. As routine maintenance, inspect regularly for any damage, repair as needed using general maintenance funds.

\$4.00/LF, lower estimate to remove and replace slats

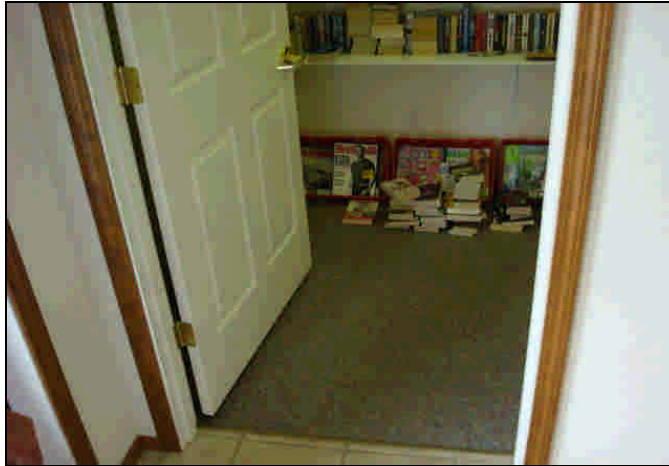
**Comp #:** 601 Clubhouse Flooring - Replace (a)

Evaluation: Generally fair condition of carpet and vinyl flooring. Some matting and wear patterns throughout. We suggest planning to replace within the next couple of years (2010 below), best timed after interior repainting (component #1110). As part of ongoing maintenance program vacuum and mop regularly and professionally clean as needed. Wide variety of type and quality available; a mid-range funding allowance is factored below for planning purposes. Note: tile should last for extended period and is not included below.

\$30/Sq Yd, lower allowance to replace, installed

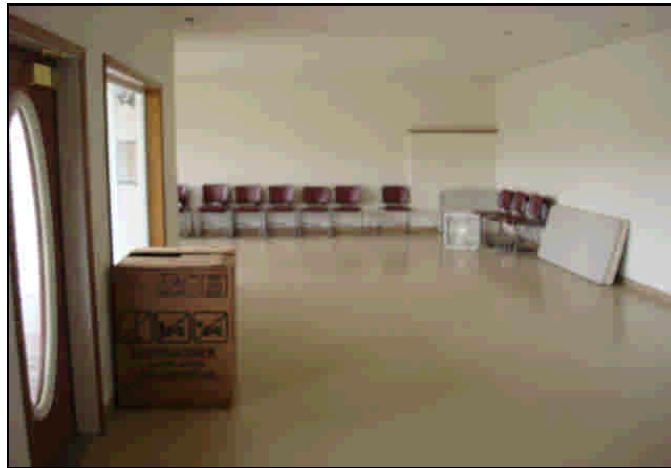
**Comp #: 601 Clubhouse Flooring - Replace (b)**

Evaluation: Generally fair condition - better than upper level, presumably due to less traffic, but some seams are showing / losing adhesion. We suggest planning to replace in roughly 5 years (2014 below), best timed after interior repainting (component #1110). As part of ongoing maintenance program mop regularly. Wide variety of type and quality available; a mid-range funding allowance is factored below for planning purposes.

\$20/Sq Yd, lower allowance to replace, installed

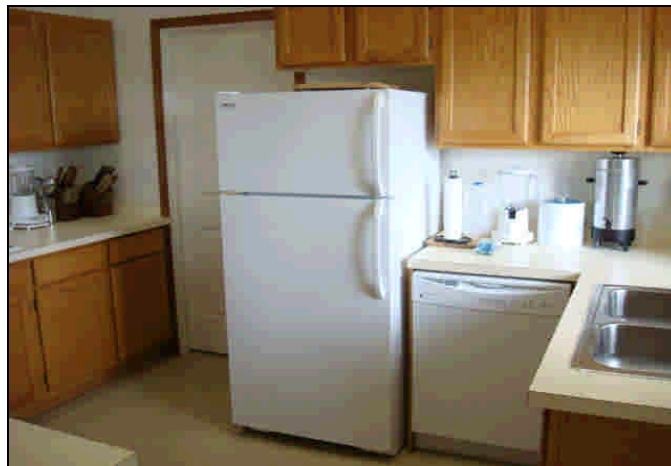
**Comp #: 901 Appliances - Replace**

Evaluation: Generally functional condition of appliances. Prudent planning suggests setting aside funds for the periodic replacement of recreation building appliances at regular intervals to maintain function.

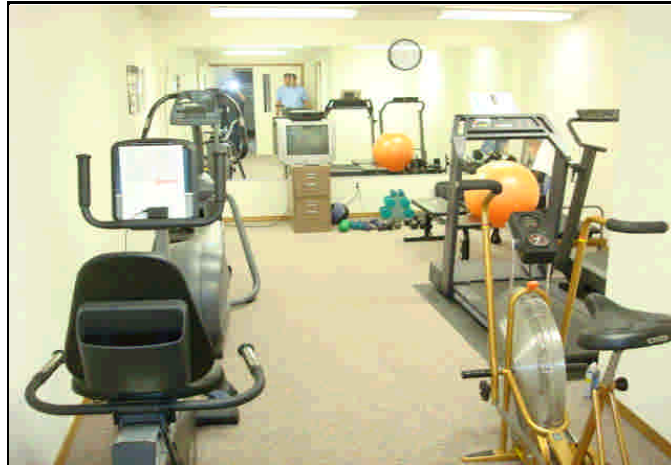
**Comp #: 902 Exercise Equipment - Replace**

Evaluation: Items are reportedly donated and in functional condition. No predictable expectation for reserve funding needs at this time. Treat small items as maintenance expense. If association desires upgrades at some point, additional equipment, etc... funding can be incorporated into reserve study updates. No basis for funding at this time.

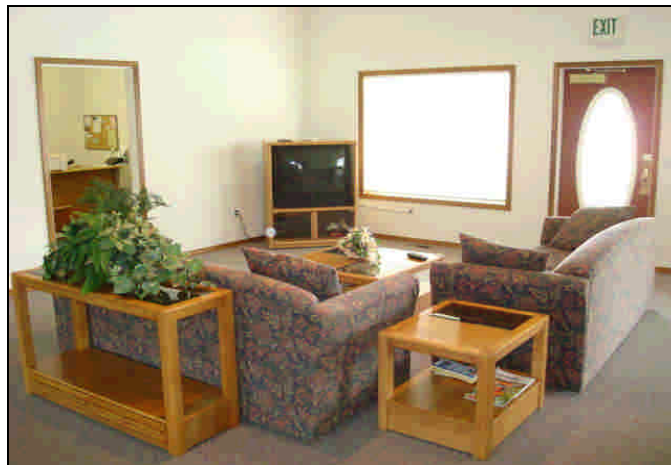
**Comp #: 903 Furniture - Replace**

Evaluation: Generally functional condition. Fabric is somewhat faded and worn in upstairs groupings. Red plastic chairs in basement are functional / utility in nature. There is no expectation to replace all at once, but best to plan for periodic partial replace, reupholster, etc... to maintain function and appearance. We suggest timing along with upstairs paint projects (component #1110).

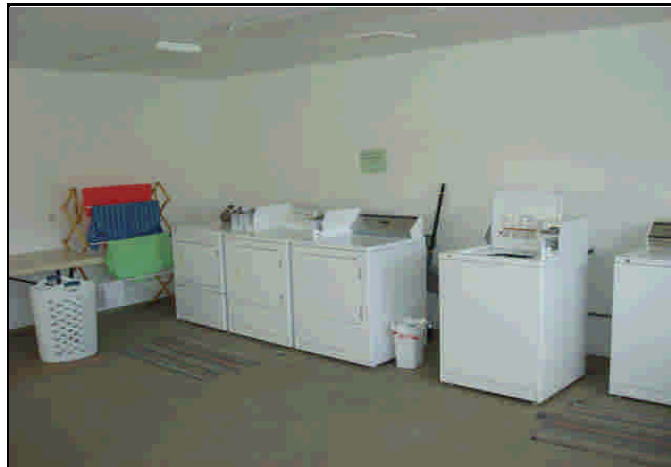
**Comp #:** 904 Washers/Dryers - Replace

Evaluation: Reported to be in functional condition, one set newer. It appears this equipment is factored within the operating budget, not as reserve component. This is proper in our opinion as replacement needs are not predictable for this type of equipment. No reserve funding appropriate under this pattern of care.

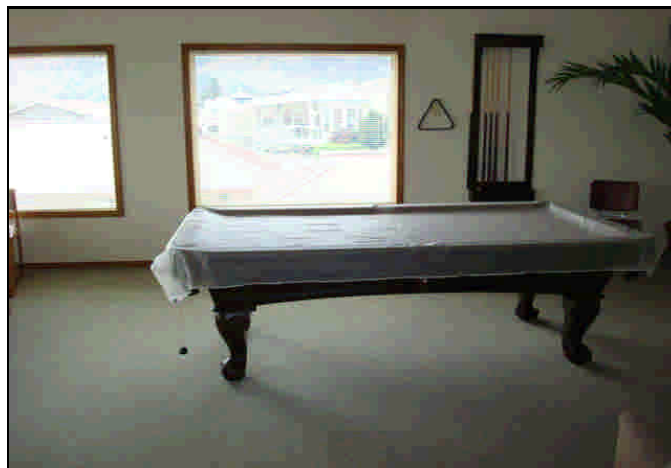
Evaluation: Good condition - recently purchased. With ordinary care and maintenance, there is no predictable expectation to replace. Replace felt, accessories, etc... when needed as general maintenance expense. No reserve funding suggested.

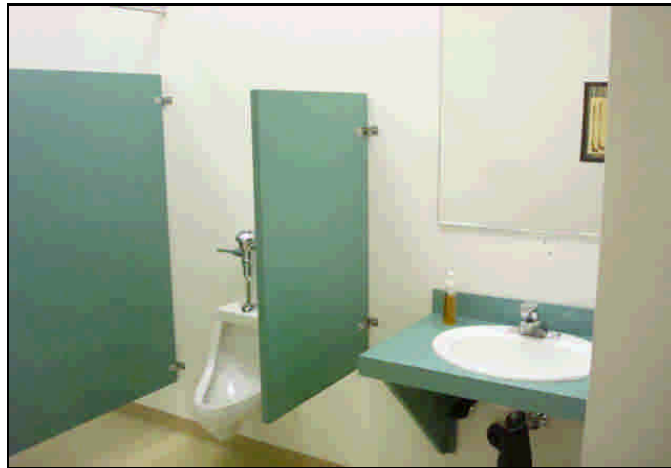
Evaluation: Functional condition. As routine maintenance, inspect regularly, perform any needed local repairs promptly utilizing general operating funds. Prudent planning suggests setting aside funds for periodic large scale refurbishing which may include items such as: plumbing fixtures, vanity area, lighting, flooring, ventilation, accessories, décor, etc...

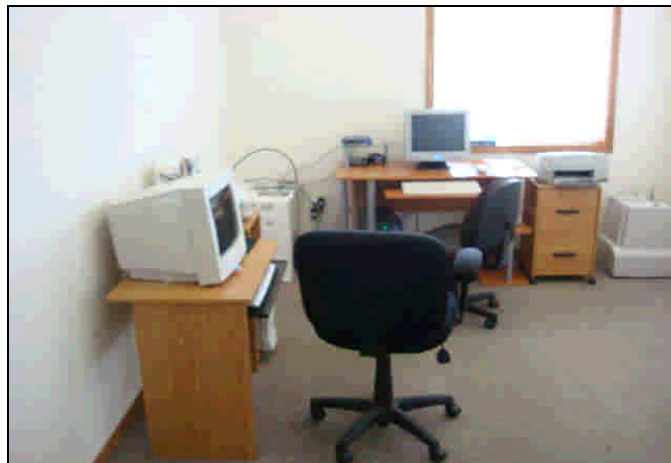
**Comp #:** 912 Office Equipment - Replace

Evaluation: Several items were donated and it appears the association purchased a copier not long ago. Expect periodic replacement needs but not on larger scale, predictable basis as reserve project. Treat as general operating/maintenance expense when needs arise.

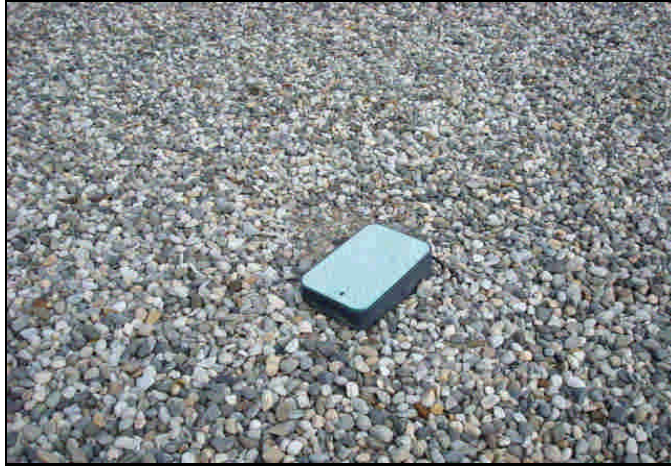
**Comp #:** 1002 Irrigation System - Repair/Replace

Evaluation: As routine maintenance, inspect regularly, test system, repair as needed from operating budget. Follow proper winterization and spring start up procedures. If properly installed and bedded without defect, the elements within this component are generally low cost and have a failure rate that is difficult to predict. Best suited to be handled thru the operating budget. No basis for reserve funding at this time.

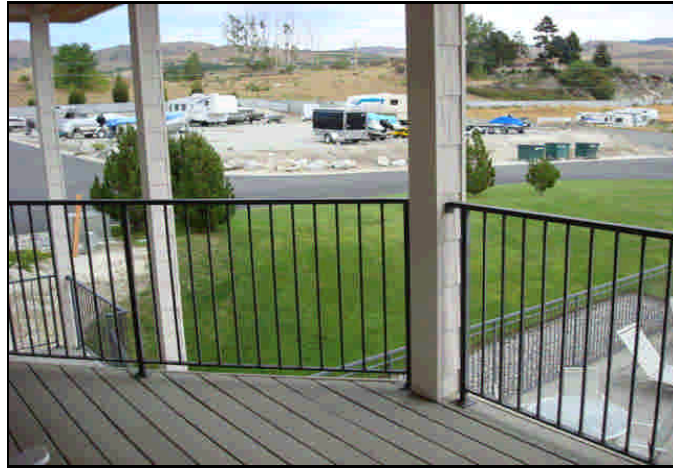
Evaluation: Fair to poor surface condition with fading and local rust throughout. We suggest setting aside reserves to paint in 2009 and roughly every 8 years thereafter to protect and maintain appearance. As routine maintenance, inspect regularly to ensure safety and stability; repair promptly as needed using general operating/maintenance funds.

\$10.00/LF, lower estimate to repaint

\$12.00/LF, higher estimate; more prep, local repair included

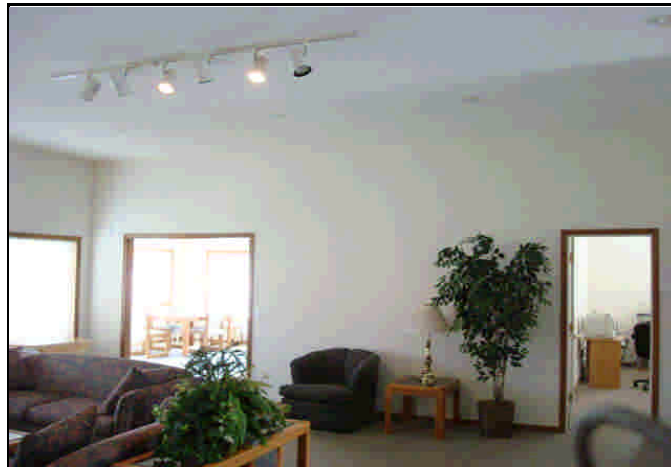
Evaluation: Fair condition - general scrapes and wear. We suggest regular cycles of professional painting to maintain appearance; best timed prior to flooring replacement (component #601). Keep touchup paint on site for in between cycle maintenance projects.

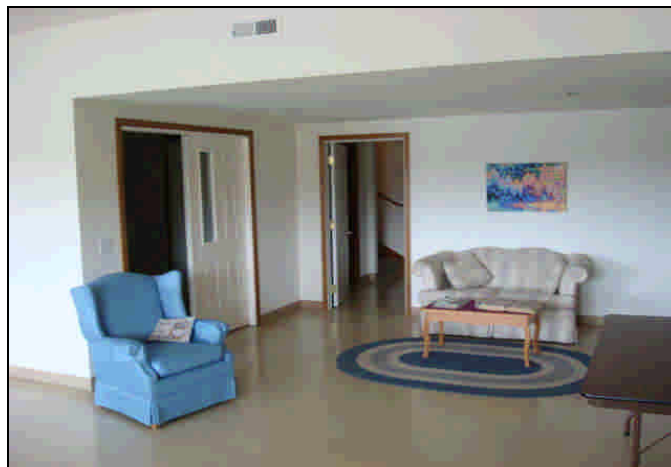
Evaluation: Fair condition - better than upper level. We suggest regular cycles of professional painting to maintain appearance; best timed prior to flooring replacement (component #601). Keep touchup paint on site for in between cycle maintenance projects.

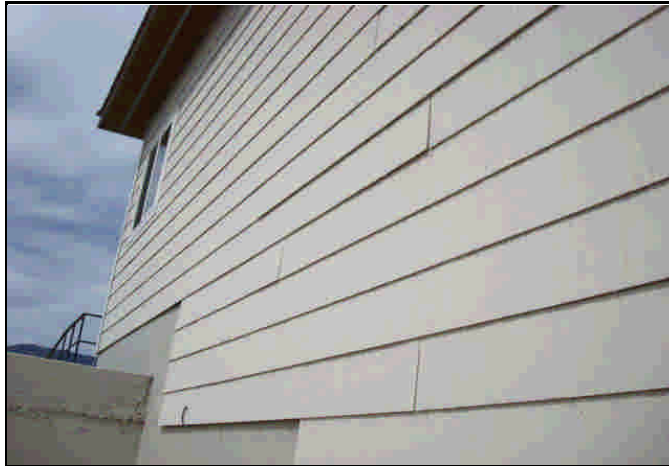
**Comp #:** 1116 Bldg Exteriors - Paint/Caulk/Repair

**Evaluation:** Generally fair to poor condition of painted surfaces with fading, failed caulking, open joints. We suggest planning to paint and repair locally as needed in 2009 and every eight years thereafter. As routine maintenance, inspect regularly and touch up / repair locally as needed. Typical Northwest paint cycles are between five to eight years depending upon surface preparation, material quality, application methods, site and weather conditions. Removal and replacement of sealant(s) with high quality product is important part of surface preparation. Repair areas of siding as needed prior to painting.

Worst Case: \$7,080.00  
\$2.00/GSF, higher estimate; includes some local repair

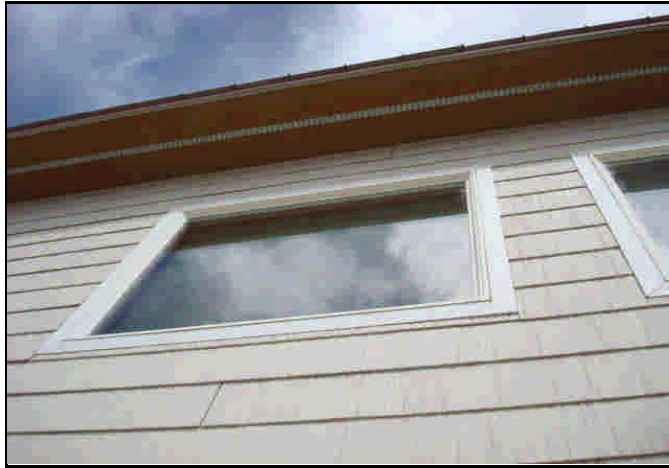
**Comp #:** 1120 Siding/Windows - Repair/Replace

**Evaluation:** Generally fair condition noted during our limited scope inspection, but we did note open joints around windows and trim, no head flashings at windows, not corner caulking... Forensic evaluation is beyond the scope of our service - we assume no hidden defect(s) exist and that proper underlying waterproofing details are in place. Association may be wise to have local contractor / building envelope professional remove critical areas to ensure proper installation and waterproofing. If installed correctly, there is no predictable expectation for large scale repair/replacement within the scope of our report. Repair as general maintenance or along with paint projects (component #11160). No basis for reserve funding at this time.

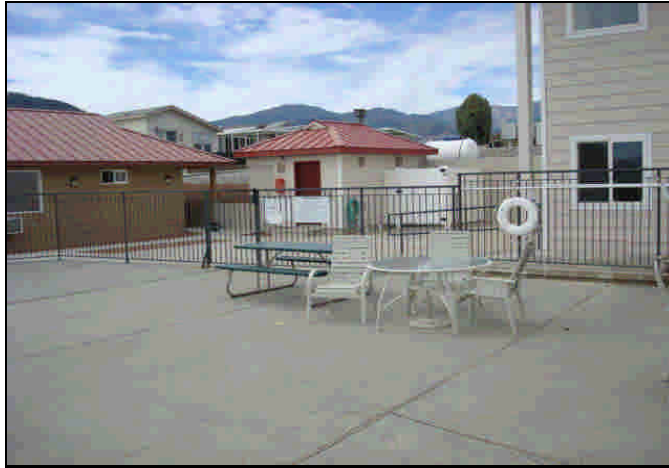
Evaluation: Generally good condition with no significant cracking or settling. Inspect regularly, pressure wash for appearance, fill/seal any cracks which may develop to minimize damage to pool deck and repair as needed from operating budget. There are a variety of ways to resurface pool decks, we recommend that as the community continues to age, that research be conducted to evaluate the associations preferred method. Plan to resurface at roughly the time frame below.

\$12.00/Sq Ft, lower estimate to resurface

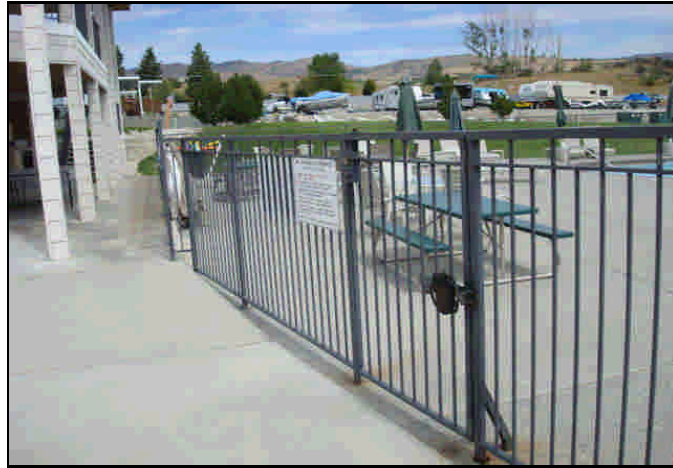
**Comp #: 1201 Pool Fence - Repair/Replace**

Evaluation: Generally stable condition. Surface is faded and there are rust spots throughout - see component #1107 for recommendation to paint at this time. Fence was reportedly inspected and passed by Health Dept. recently with addition of top mounted latch mechanism. We suggest planning to eventually replace this fence at time of pool deck resurface (component #1200). Repair locally as maintenance project or include with paint.

\$60/LF, lower allowance to replace

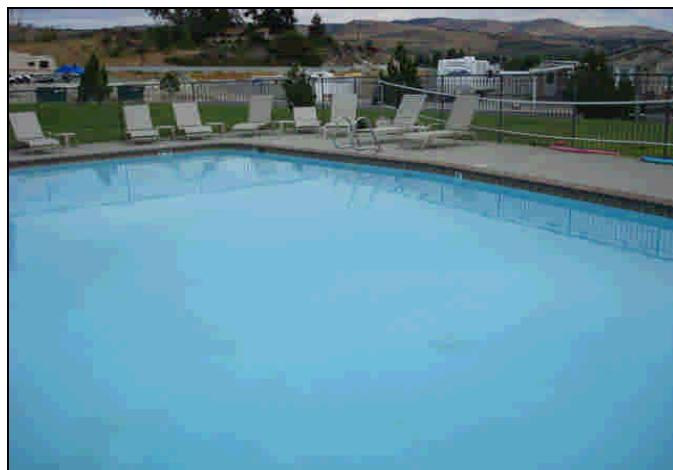
Evaluation: Fair to poor condition of surface with some cracking and general pitting of plaster. Pool is used frequently, kept at 81 degrees and is not reported to be covered. We recommend professional cleaning and maintenance to maximize life; maintain proper chemical balance. Plan for regular intervals of pool resurfacing to maintain function and a quality surface, appearance.

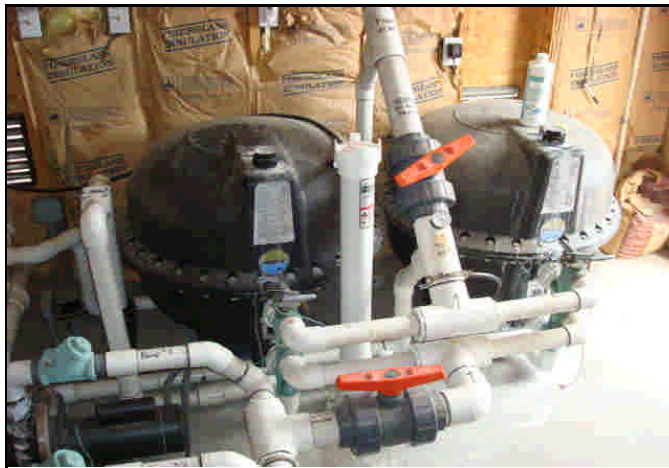
**Comp #: 1207 Pool Filters - Replace**

Evaluation: Generally functional condition of filters - some corrosion, leaks. As routine maintenance, inspect regularly, clean / back flush, change sand and repair/replace as needed. Replacement cycles are estimated to be in the 15 year range per vendor, Pool to Spa.

Best Case: \$2,000.00  
\$1,000/ea, lower estimate to replace; installed

Worst Case: \$2,800.00  
\$1,400/ea, higher estimate; upgraded, additional job scope

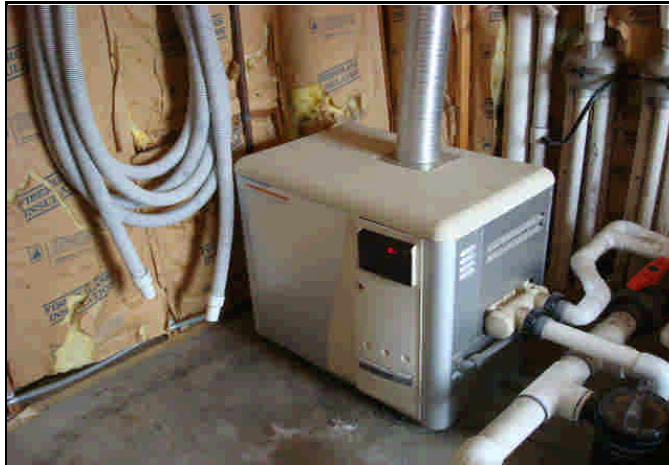
**Comp #:** 1208 Gas Pool Heater - Replace

Evaluation: Generally good operating condition; reportedly replaced within the last few years. We recommend ongoing regular professional inspections, maintenance and repair to help maximize life. Typical life expectancy indicated below per installation vendor.

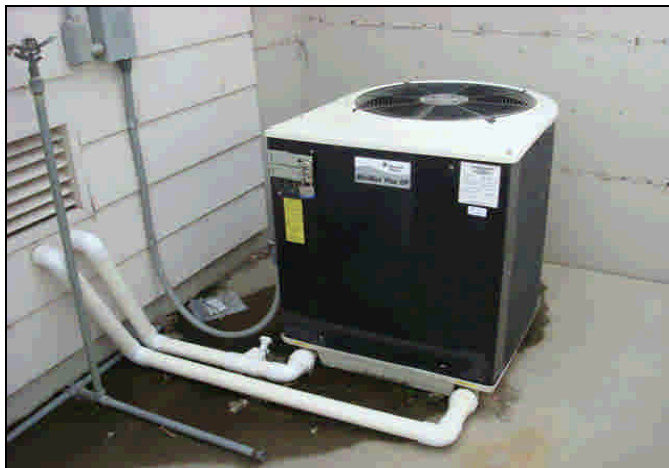
**Comp #:** 1209 Pool Heat Pump - Replace

Evaluation: Generally good operating condition. Plan to replace at roughly the 10 year mark of life per installation vendor. Regular inspections and cleaning is recommended for best performance and maximum life.

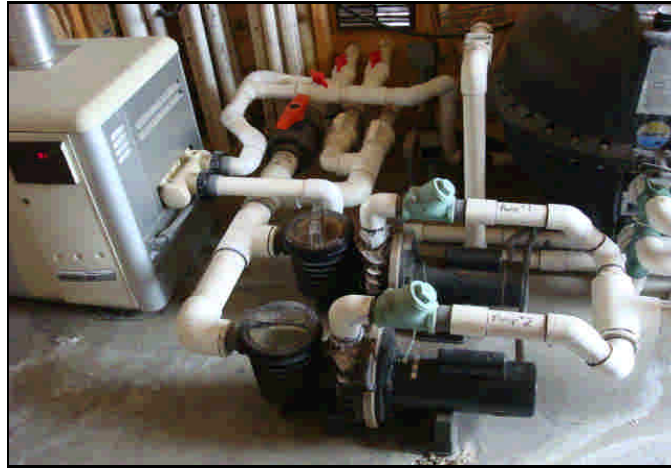
**Comp #:** 1210 Pool Pumps/Valves - Replace

Evaluation: Assumed to be functional condition. We recommend regular professional inspections and maintenance. Failure rate of these types of components is difficult to predict and can often be rebuilt instead of replaced (<\$500). Therefore, not suitable for reserve designation at this time. Treat as general operating/maintenance issue when repair/replacements are needed.

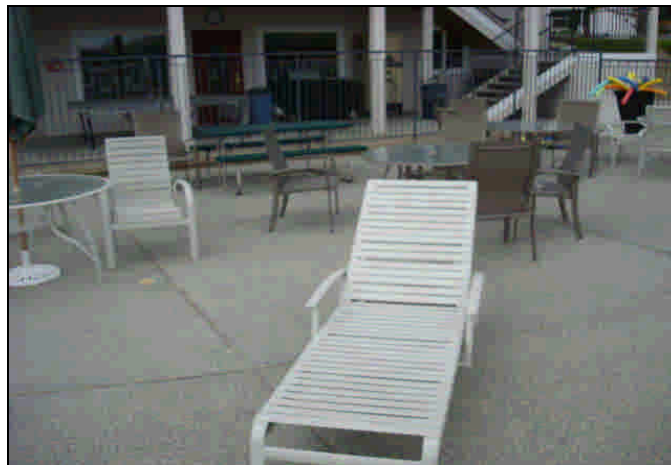
**Comp #:** 1211 Pool Furniture - Replace

Evaluation: Varying age and condition - generally stable / functional. Newer furniture was reportedly purchased using proceeds from yard sale. No expectation to replace all at once, but we suggest setting aside funds for periodic partial replacement every few years to continue function and appearance.

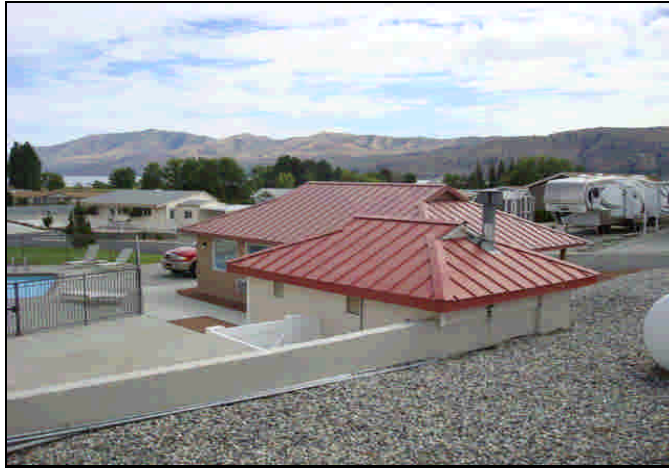
**Comp #:** 1303 Building Roof - Repair/Replace

Evaluation: Generally good condition observed during our limited scope visual inspection. We assume roof was installed per manufacturers specifications and applicable building codes. As routine maintenance, we recommend professional inspections at least twice annually and after windstorms. Promptly replace any damage or any other repair needed to ensure waterproof integrity of roof. Fastener grommets should be checked regularly and replaced if deteriorated. Plan for replacement at roughly the time frame indicated below.

\$8.00/Sq Ft, lower estimate to remove and replace roof

\$10.00/Sq Ft, higher estimate; upgrades, underlying repair needs

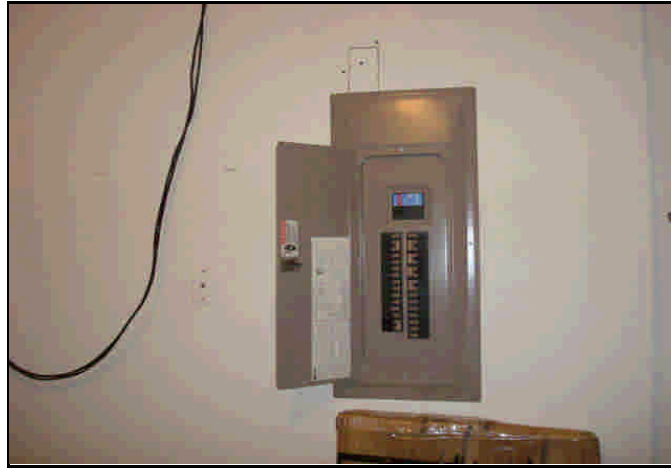
**Comp #:** 1811 Electrical/Plumbing -Repair/Replace

Evaluation: Analysis of these hidden systems is beyond the scope of our services. No reported problems or deficiencies. Typically, if installed per architectural specifications and local building codes, there is no predictable time frame for large scale repair/replacement expenses within the scope of our report. If leaks, poor flow / water quality, extensive tripping of breakers, etc... become evident, have qualified professional inspect closely and develop scope of repair/replacement. Treat minor repairs as ongoing maintenance expense. If patterns of significant repair emerge, funding may be incorporated into future reserve study updates. No basis for reserve funding at this time.

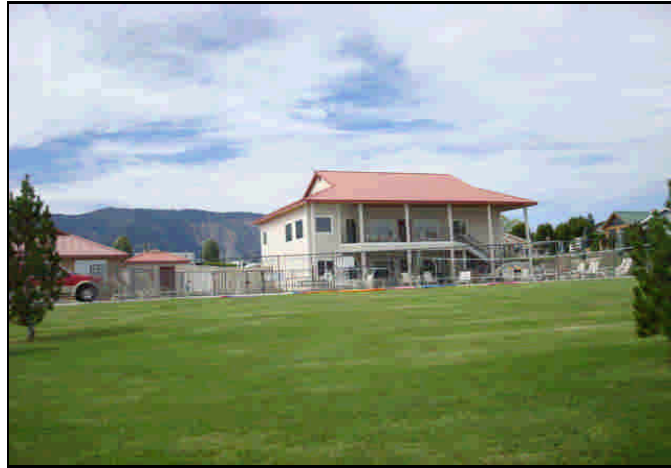
Evaluation: Typically funded as ongoing maintenance item, this component may be utilized for setting aside funds for larger expenses that do not occur on an annual basis, such as: large scale plantings, extensive bark mulch every two/three years, resodding lawn areas, landscape improvement projects, etc... No basis or stated desire to fund at this time, these types of expenses may be incorporated into future reserve study updates as needed, desired.

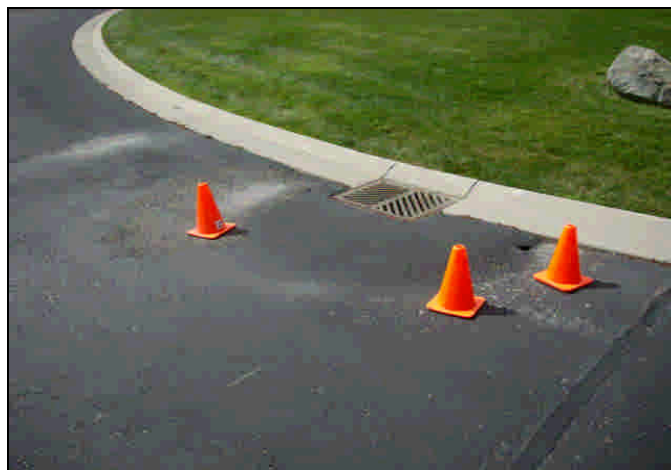
**Comp #:** 1902 Drainage System - Maintain/Repair

Evaluation: Assumed to have been properly designed with adequate provisions for community drainage needs. As routine maintenance, inspect regularly, keep drains and grates free of debris and free flowing to ensure water evacuating as designed. Pump out sediments if needed utilizing mobile evacuator service; fund from operating budget. No expectation of large scale repairs/replacement at this time. No reserve funding suggested.
